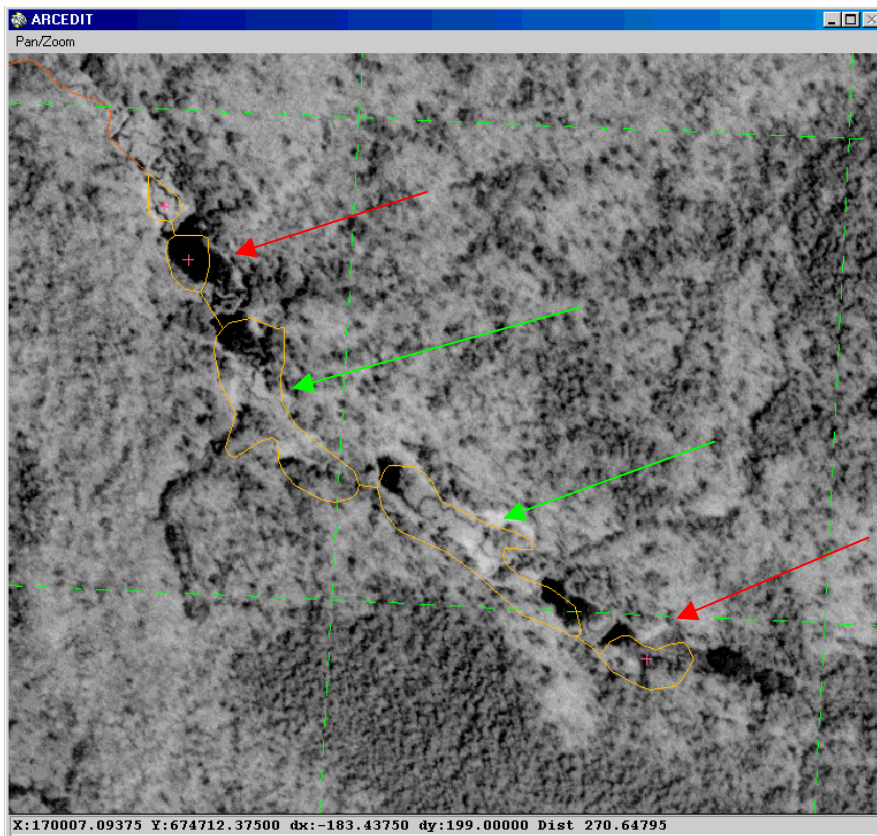
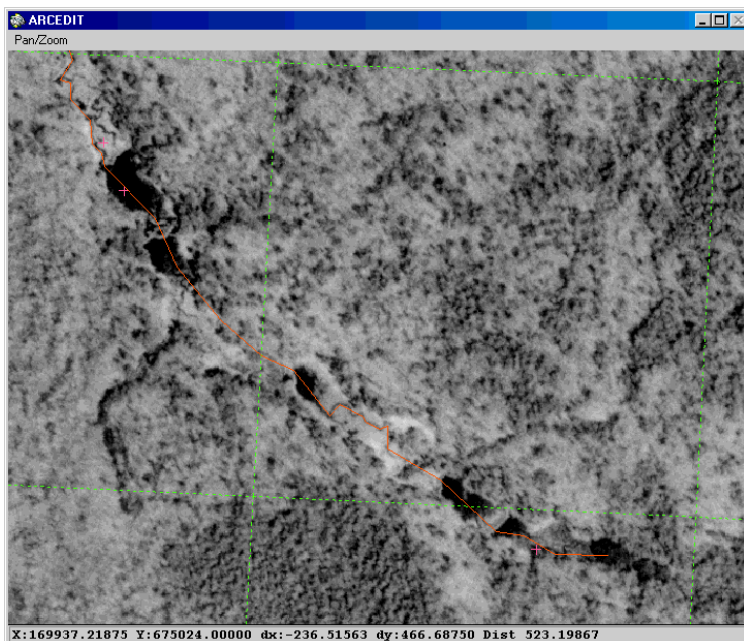
→ Two ponds are less than one acre and are somewhat visible.

→ Two ponds greater than one acre are not visible any longer.

Proposed solution was to remove the small polygons and extend stream headwaters.

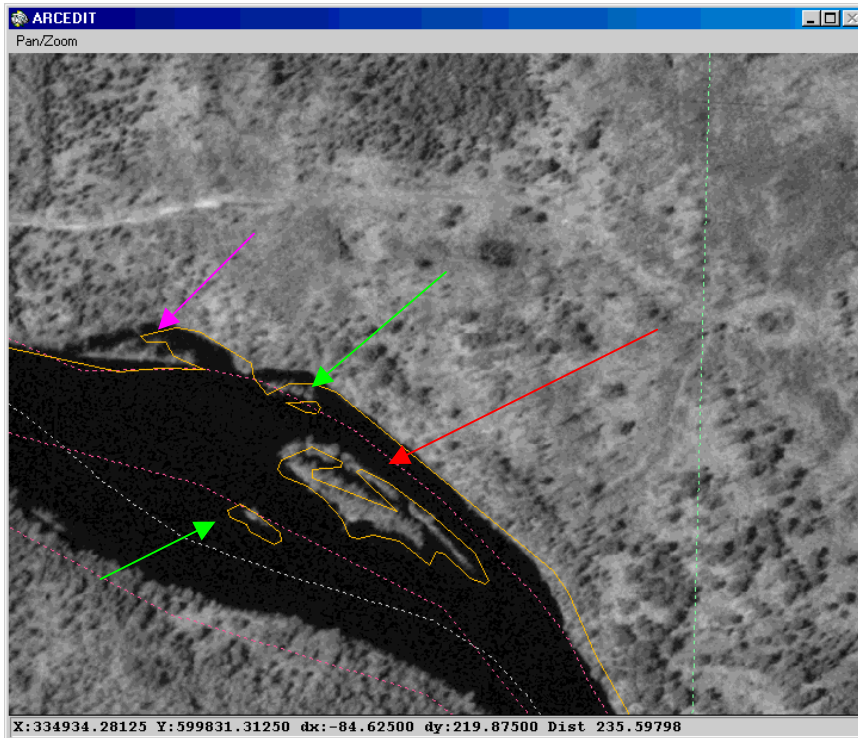
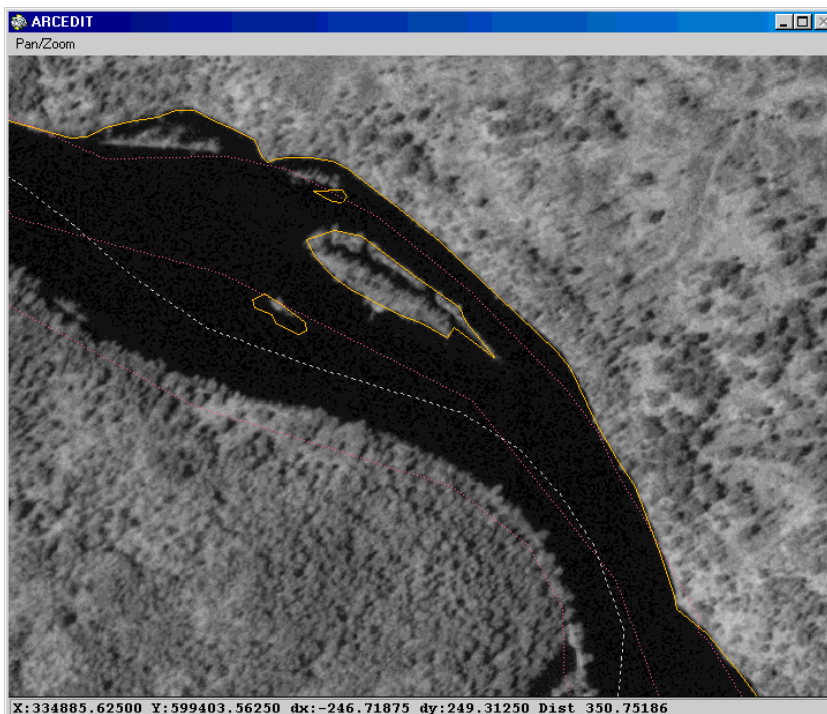
- Island polygon in coverage is > 1 acre, however, the largest island visible is < 1 acre – proposed solution was to reposition the island polygon around all four islands grouped together.
- Two other small islands (< 1 acre) in river left untouched.
- Shoreline repositioned off small island.

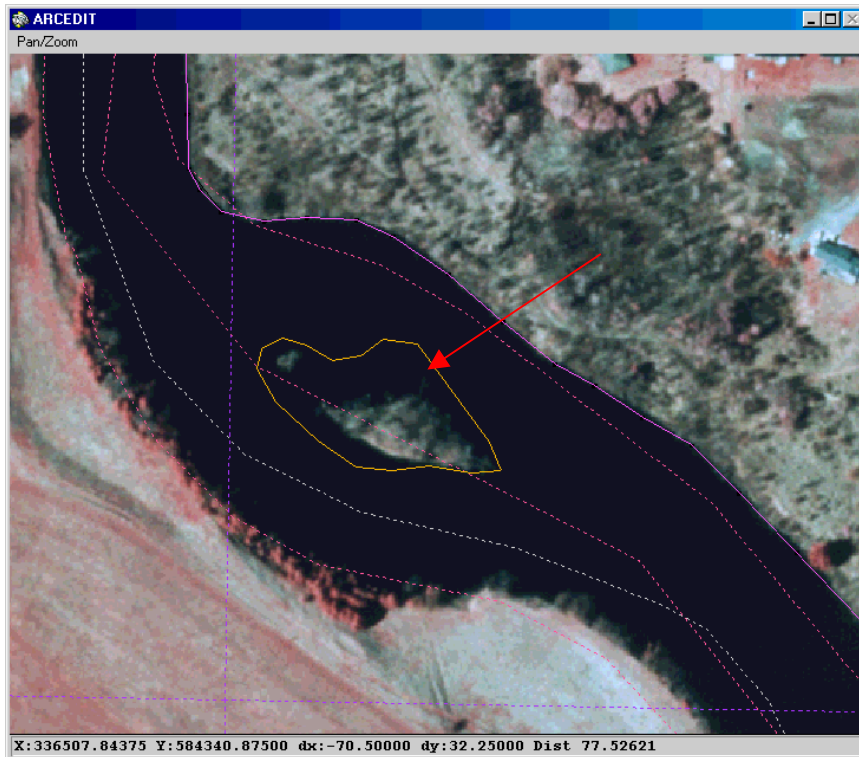
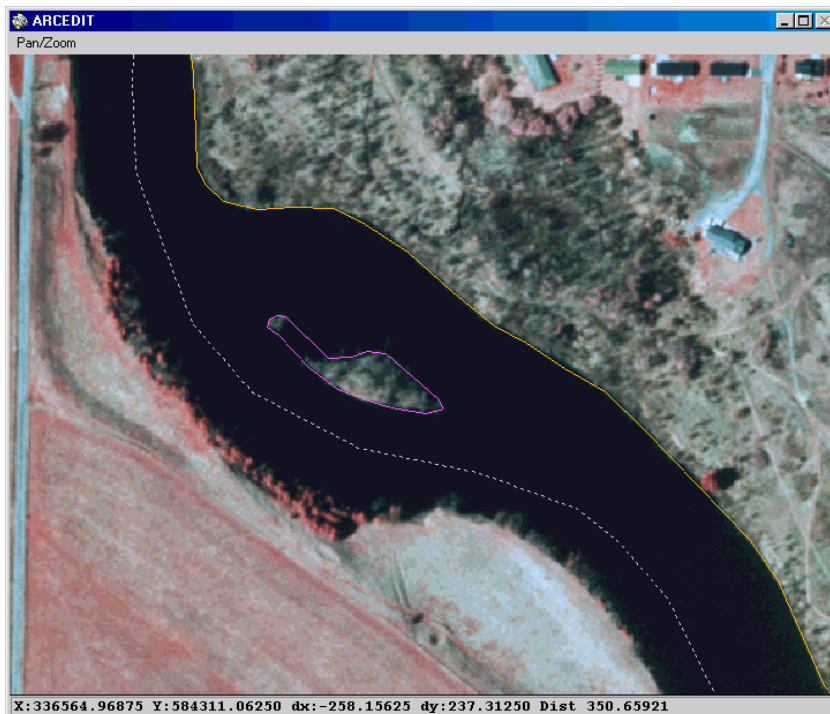
Island polygon is > 1 acre, but visible island size is < 1 acre – proposed solution was to slightly modify polygon shape.

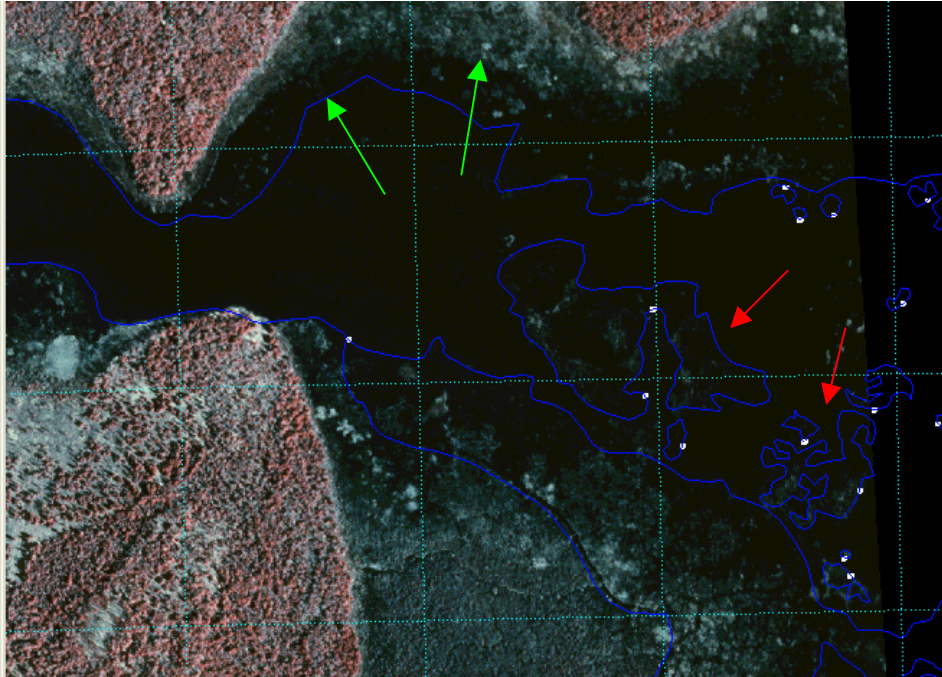
- Lake with remnant island polygons – proposed solution was to remove extraneous polygons.
- Shoreline not representing features on image – proposed solution was to reposition shoreline along the darkwater line, nearest to where open water meets vegetation as can be discerned by the photo.
